Comparison of off-chip interconnect validation to field failures

David Blankenbeckler, Adam Norman

Abstract— Memory subsystem errors continue to be a common problem in modern computer systems. Through a large scale field study, this paper will introduce the interconnect transient margin validation metrics and compare to the observed field failures. The results will demonstrate that transient bus errors are not a dominant cause of system memory problems.

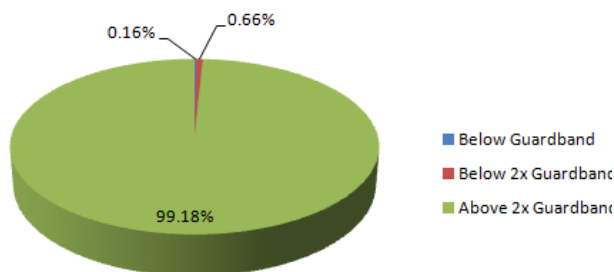
The systems which required DIMM replacement were cross-referenced back to the bus margin data collected for that specific system when it was tested at the factory. The bus margin for these systems was then compared against the minimum bus margin guardband expectation. The data in Figure 8 shows that only a small proportion of the systems requiring DIMM replacements contained low margins at the time the system was shipped from the factory. Only 0.16% of the systems were below the margin guardband and in fact, even if you double the guardband, this would still be less than 1% of systems.

Clearly, the margins on the memory bus are a minor factor driving field DIMM replacements for the population of systems under study. What is driving these replacements then? Unfortunately, detailed failure analysis was not possible for the failures returned from customer sites, but we can use the data we have to draw some important conclusions. The factory bus margin data indicates that both the CPU and DRAMs have sufficient voltage and timing margin to ensure robust data transfers. Assuming that bus margins have not degraded over time, there is a strong indication that signal integrity issues are not a major factor in memory failure rates. Considering that the sub-population of systems requiring a DIMM replacement included 32 unique DIMM part numbers across 5 different vendors, margin degradation due to aging seems unlikely. While it might be reasonable to assume that a particular DRAM design might have degradation problems due to aging, it is

Given that these DIMM failures don't correlate to low bus margins as measured in the factory and it seems unlikely that DRAM I/O degradation is a widespread problem, it is assumed that these DIMM replacements are largely driven by internal DRAM issues.

Figure 8. Chart shows the percentage of systems with low bus margin. This is for all field memory failures within our data set.
