The Assessment of Environmental Changes of Selected Water Bodies in the Area of Cracow over the Past Two Decades

Abstract—Six water bodies or their complexes - four in Cracow and two in the Commune of Niepołomice, Southern Poland - were studied focusing the changes they have undergone and the present state from the point of view of their attractiveness to the visitors. The degree of threat to the water bodies was also assessed. The highest grades were given to the ponds of Niepołomice (Zamkowa), due its well management. The lowest grades were attributed the ponds of Płaszów (also the most threatened pond) and Staniątki (probably a temporary situation). The least threatened complex of water bodies is the one in Przylasek Rusiecki. Two of the described water bodies (Dąbie and Staniątki) diminished their area within the last 20 years and the pond of Płaszów diminished earlier.

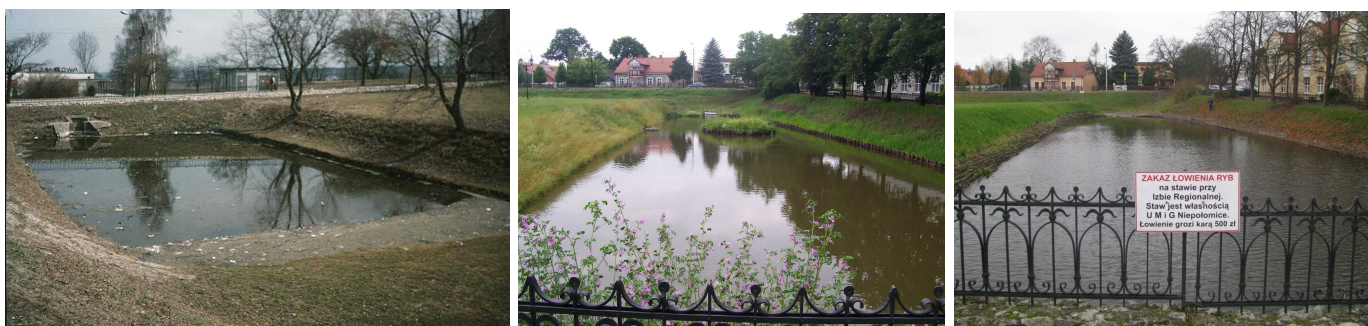
Figure. 1. The pond in Niepołomice. Left: April 1996 – view from the eastern side (Zamkowa Street); centre: July 2005 – view from the western side (3Maja Street), the pond after the renovation works – the islet is visible; right: October 2015 – the islet is appeared, the note saying that fishing is forbidden was put. Previously the pond was used for fishing, photos: A. Wagner.

5. Niepołomice – Zamkowa street - 0.1 ha. The pond undergone restoration works in 2005. The shores were reinforced with wicker and an islet was formed in the middle. However, after a few years the islet submerged. Significant changes in the surroundings were also observed. The pond was originally an anti-fire reservoir and fishing pond. Nowadays fishing is forbidden and the pond has a decorative function, as a part of the local ethnographic museum [5]. Some changes were illustrated in the photographs in Figure 1.

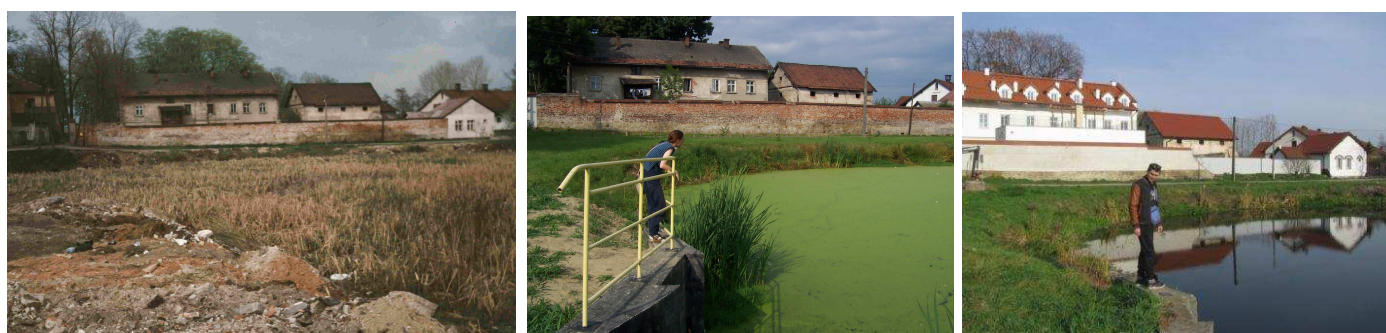
Figure 2. The fragment of the Staniątki Pond. Left: 2nd May 1996; centre: 1st August 2005 – the railing was built; right: 10th November 2015 – the white building on the left is the newly built nursing home, the railing was removed, photos: A. Wagner.

6. Staniatki (the Commune of Niepołomice), Figure 6. – two ponds near the Benedictine Convent in Zagórska street , 0.12 and 0.05 ha. Originally, it was one pond, with a bigger surface. It served as a fishing pond. Later on it was abandoned, but in 1996 the project of management was accepted. In 2005 facilities such as a railing and teeters were built. They were destroyed due to the construction works regarding the neighbouring buildings [5]. Changes were illustrated in the photographs in Figure 1.
